A REPORT OF THE FORT VANCOUVER ARCHAEOLOGICAL EXCAVATIONS OF THE
NORTH WALL

by
JOHN D. COMBES

1966

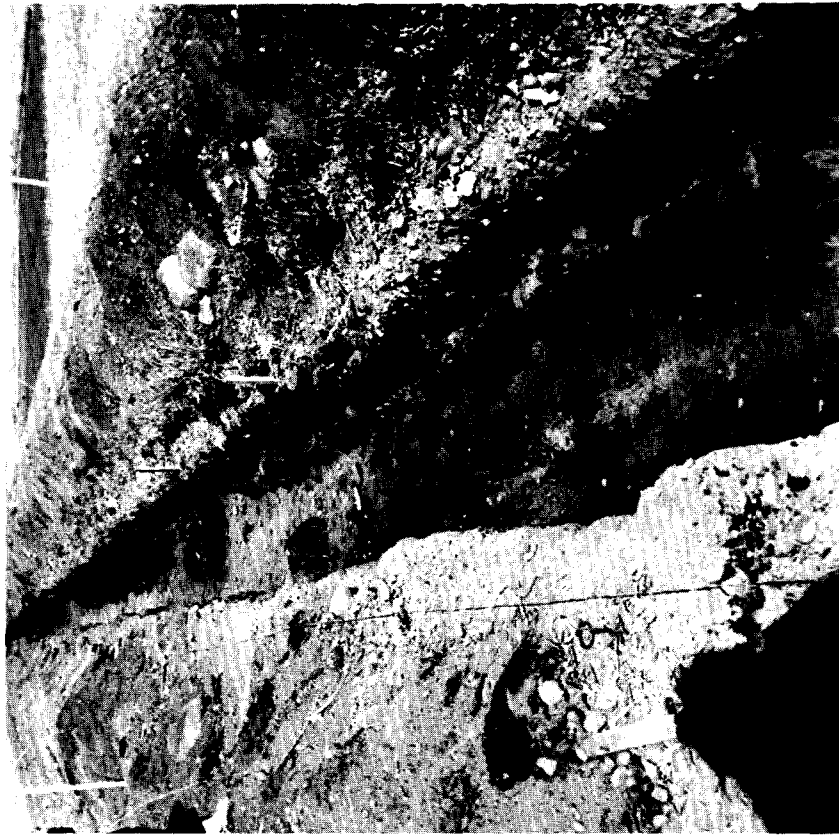
Fig. 2.--Photograph of old palisade butt remains.
View facing east.

In sections of the wall where the post butts were in good condition, diameter measurements were taken and averaged. Sizes of the posts ranged from five inches to ten inches in diameter with an average size of 7.2 inches. The number of posts used per hundred feet was approximately 120. These figures were also taken in sections where there was no disturbance and where the posts were in the best condition. Figure 2 is a photograph of the exposed palisade butts.

This means, then, that in a running ten foot section, 86.4 inches is taken up by logs and 33.6 inches is taken up in gaps or an average of 2.8 inches between each post. It is doubtful that they were originally placed in the trench that way. Perhaps our measurements are lessened due to decay of the outside surface of these posts. To the best of our knowledge these logs were not skinned. If they were not, the bark would decay rapidly and leave this sizable gap between the posts. No evidence of bark was encountered during these excavations. This would increase the size of the original logs to between eight and ten inches.

The tops of the post remains all seemed to be located from 12 to 18 inches below the present surface. The bottoms, for the most part, went to a depth of four feet below the present surface. The surface of occupation during the existence of Fort Vancouver was also around 12 to 18 inches below the present surface. The build-up over the original surface can most likely be attributed to later use of the area by the mill, the army, and leveling of the entire area for use by the airport.

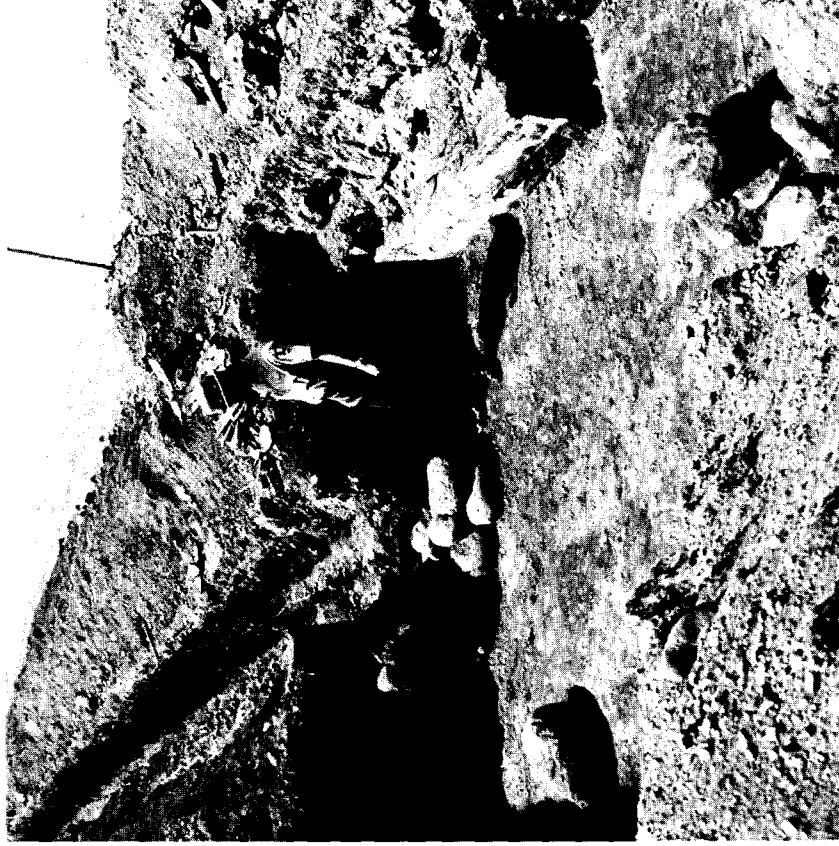
Fig. 3.--Photograph of north gate area.
View facing northwest. (N.P.S. photo)

The two rock piles looked promising and with the absence of vertical posts it was decided to expand the trench six feet to the north and six feet to the south for a distance of 15 feet to take in the entire suspected gate area. Figure 3 is a photograph of the results. The large river rounded stones did in fact turn out to be rock piles. It was planned to excavate a trench outside of the gate in an attempt to locate the road leading into the fort. The expanded trench revealed a concrete footing from the spruce mill three to four feet outside the gate. It was fortunate that this footing was not four or five feet further south obliterating the entire gate area.

The evidence looks very good for this being the actual location of the north gate. The rock piles appear to be reinforcements for the vertical posts that supported the heavy gates. There was an absence of vertical post butts through this area. There were horizontal pieces of wood. This may well be what remained of a corduroy road lining through this entrance. Apparently these gates were massive structures about six or seven inches thick and heavily studded with large nails (Hussey, 1957;133). It is noteworthy that a much higher frequency of nails, especially large nails, was recovered in the gate area. Of the ten foot excavation units previously not excavated by Caywood, an average of six nails were recovered per unit, whereas at the gate area in the ten foot excavation unit 59 nails were
